# Commercial Roof Inspection Report

Roof condition, repair priorities and budget options

| Property | Sample Property, Boston, MA | Inspection date | October 2026 (dry weather) |
| Roof system | Low-slope roof, white reflective single-ply membrane | Prepared by | ID Flat Roof |

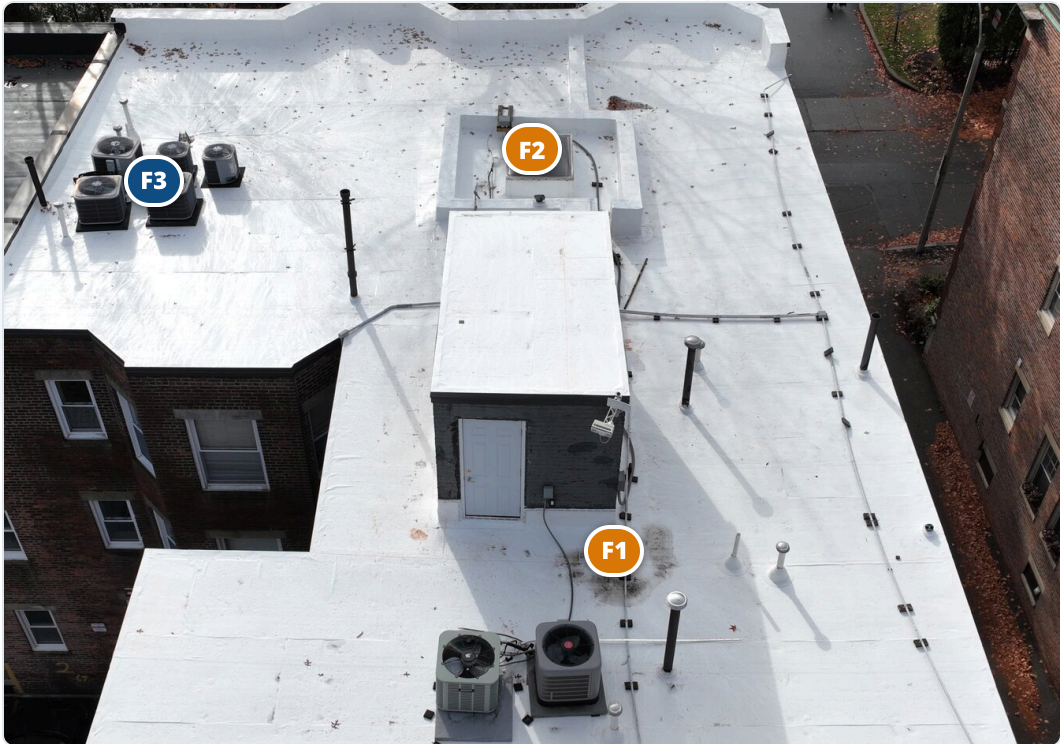
- F1** Beside the bulkhead  
This Season
- F2** Skylight well and rear roof  
This Season
- F3** Five-unit condenser group  
Monitor

Drone overview of the whole roof: rooftop bulkhead, skylight well, seven condenser units in two groups, vent pipes and the scalloped rear parapet. Markers F1–F3 show Findings 1–3 (page 3).

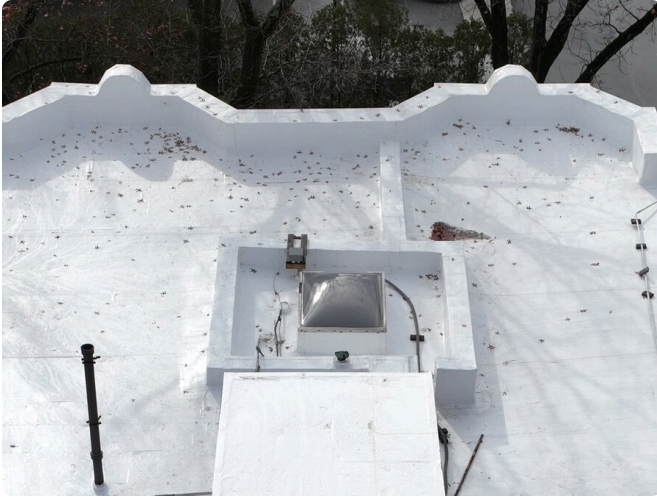
- No punctures, splits or open seams were seen.
- Flashings at the bulkhead, skylight curb, parapet and roof edge are in place.
- Leaves and small debris on the rear roof by the parapet (Finding 2).

Photo: Rear scalloped parapet; the membrane runs up and over it.

| # | Photo | Location and finding | Recommended action | Priority |
|---|---|---|---|---|
| F2 | | <b>Skylight well and rear roof</b><br>Leaves and debris in the well corners and on the rear roof by the parapet. | Clear before winter; repeat at spring and fall maintenance. | <b>THIS SEASON</b> |

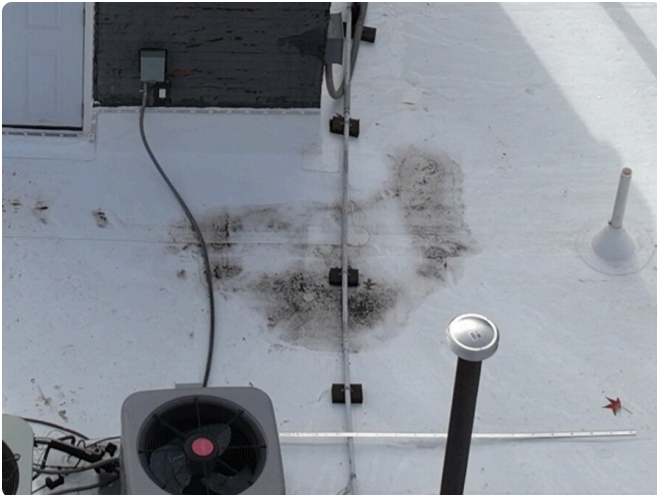
- No standing water at the time of inspection (dry weather).
- Beside the bulkhead, staining and dirt build-up suggest water may sit there after rain; recheck after heavy rain (Finding 1).
- Leaves in the skylight well and on the rear roof can slow drainage after rain (Finding 2).

Photo: Area beside the bulkhead, with conduit and a loose cable (Finding 1).

| # | Photo | Location and finding | Recommended action | Priority |
|---|---|---|---|---|
| F1 | | <b>Beside the bulkhead</b><br>Staining and dirt build-up; a cable from the bulkhead lies loose on the membrane. | Clean the area and check it for membrane damage; set the cable on support blocks; recheck after heavy rain. | <b>THIS SEASON</b> |

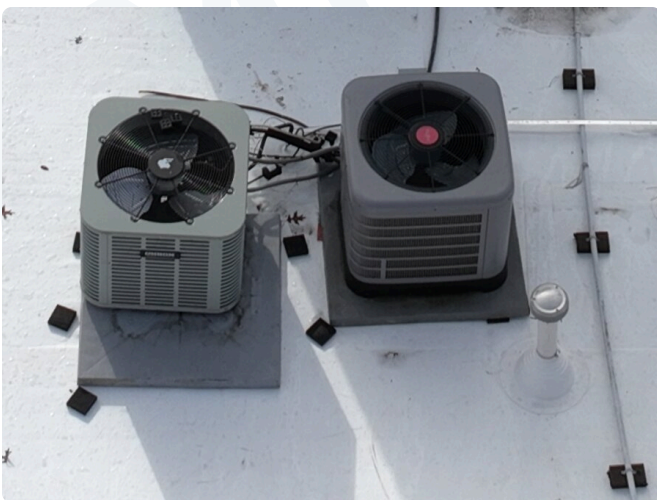
- Seven condenser units in two groups (five and two), all on pads; the membrane around the pads is intact (Finding 3).
- Vent pipes have flashing boots; no gaps were seen.
- The skylight sits on a raised curb in a membrane-lined well; the curb flashing is in place.
- Conduit runs on support blocks; one cable lies loose on the membrane (Finding 1).

Photo: Two condenser units on pads, with refrigerant lines; a vent pipe with a flashing boot.

| # | Photo | Location and finding | Recommended action | Priority |
|---|---|---|---|---|
| F3 | | <b>Five-unit condenser group</b><br>Foot traffic during HVAC service; membrane intact now. | Check the membrane at the pads at each inspection and after HVAC service. | <b>MONITOR</b> |
